**Flood Control Project Maintenance
Levee Inspections**
LMA District Cover Sheet
Spring 2019 Levee Inspection Results

Eastern Honcut Creek

Spring 2019 Levee Inspection Results

Waterway			Bank	Unit Miles
Unit No. 01 Van Tress			Left	1.46
	Spring (March - May)	Summer (June - August)	(September - November) Fall	Winter (December - February)
Unit Maintenance Rating (Fall Only)				
Date of Inspection	4/24/2019 - 4/24/2019			
DWR Inspector	Sterling York			
Accompanied By	Jimmy Vantress Farmer

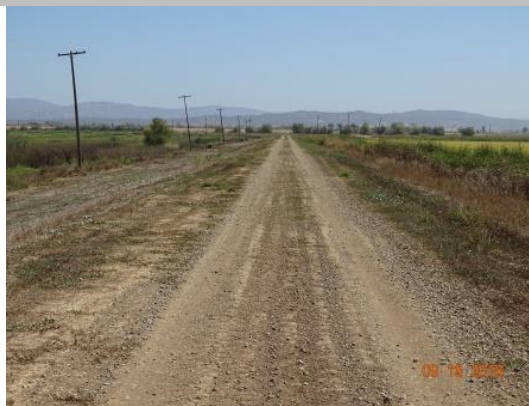
Photo 1 of 1 : SP_2019_NA0006_252_21_20190305_00007.jpg

LM Start	0.02	Rating **	U	Issue No.	21
LM End	0.66	Issue Type +	Ma	Location *	CR
Category	Earthen Levee			GPS Latitude/Longitude	
				Start	End
Item	Crown Surface / Depressions / Rutting			39.298504 °	39.297595 °
				-121.569502 °	-121.558310 °
DWR ID	DWR_NA0006_01_s_2015_21				
Comment Code					
C3 : Add appropriate gravel or road base. Grade and compact.					
Inspector Comment					
Place appropriate gravel on the crown roadway to make it an all weather road.

View of the crown looking upstream of a section of road that needs all weather surface. Fall 2018.

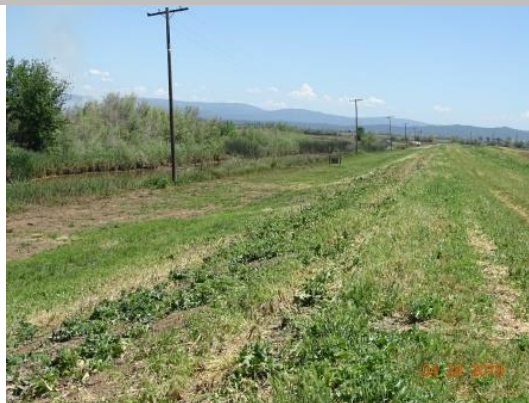
Photo 1 of 1 : SP_2019_NA0006_252_11_20190429_00027.jpg

LM Start	0.06	Rating **	A	Issue No.	11
LM End	0.67	Issue Type +	Ma	Location *	WS
Category	Earthen Levee			GPS Latitude/Longitude	
				Start	End
Item	Vegetation			39.299081 °	39.297468 °
				-121.569246 °	-121.558305 °
DWR ID	DWR_NA0006_01_s_2019_11				
Comment Code					
V1 : Control annual grass and weeds on the levee slopes and easements.					
Inspector Comment					
The annual vegetation is well maintained in this section, Spring 2019.

View looking upstream waterside at the annual vegetation and wild growth that that is well maintained in this section, Spring 2019.

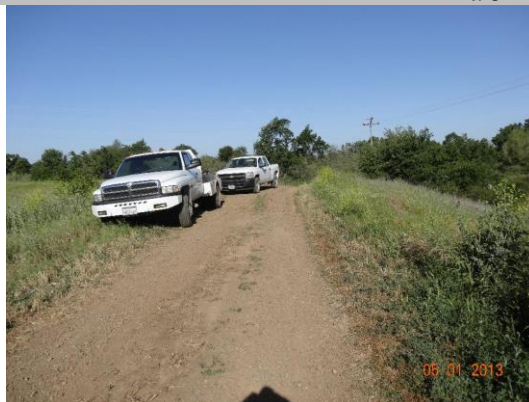
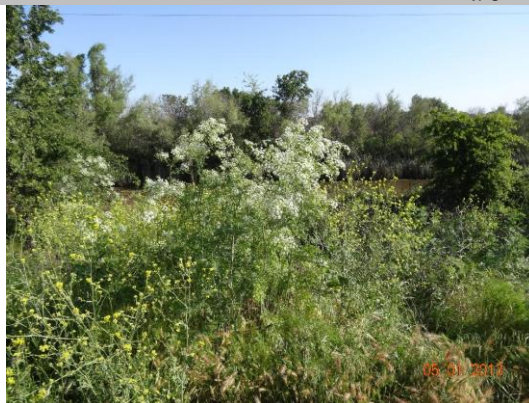
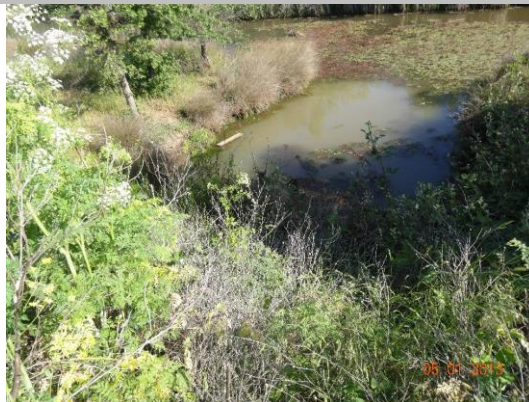
LM Start	0.09	Rating **	M	Issue No.	27
LM End	0.09	Issue Type +	Ma	Location *	
Category	Supplemental			GPS Latitude/Longitude	
				Start	End
Item	DWR UCIP LMA Responsibility			39.299106 °	39.299106 °
				-121.568749 °	-121.568749 °
DWR ID	19168				
Comment Code					
Inspector Comment					
FS_ID:52801 DS_ID:19168 EP_NO: N/A Repair Type: Non-Urgent Crossing Status: Found UCIP Comments: 05/01/2013 Dense vegetation on waterward side and landward side obstructs inspection. Need to clear vegetation on slopes to conduct proper crossing evaluation. (DWR UCIP - O. Magana) FIELD_STRUCT_DESC: 24-inch corrugated metal drainage pipe through the levee, 10 feet below the crown. Flap gate located on the waterside (WS) end. [Additional Reference(s): DWR Levee Logs, 2005. USACE Sacramento O&M Manual Unit No. 151, November 1953, (Station 5+65)] FS Date: 5/1/2013

Overview of levee crown at crossing looking upstream.

Dense vegetation obstructing waterward slope.

Overview of waterward side (outlet).

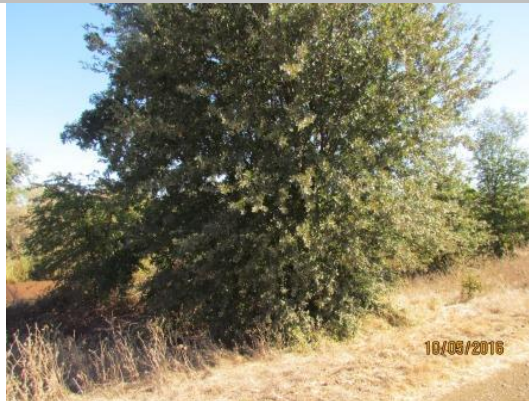
Photo 1 of 1 : SP_2019_NA0006_252_22_20190305_00008.jpg

LM Start	0.10	Rating **	M	Issue No.	22
LM End	0.10	Issue Type +	Ma	Location *	WS
Category	Earthen Levee			GPS Latitude/Longitude	
				Start	End
Item	Trim / Thin Trees			39.299078 °	39.299078 °
				-121.568633 °	-121.568633 °
DWR ID	DWR_NA0006_01_f_2016_22				
Comment Code					
T1 : Trim trees to at least five feet above ground level.					
Inspector Comment					
There is a tree that needs the limbs trimmed up 5' for visibility and access on the waterside.

View of a tree that needs the limbs trimmed up 5' for visibility and access on the waterside.

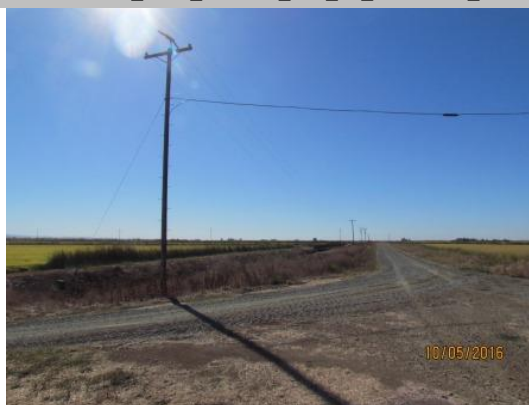
Photo 1 of 1 : SP_2019_NA0006_252_17_20190305_00004.jpg

LM Start	0.66	Rating **	M	Issue No.	17
LM End	1.45	Issue Type +	En	Location *	WS
Category	Earthen Levee			GPS Latitude/Longitude	
				Start	End
Item	Encroachments			39.297629 °	39.295257 °
				-121.558337 °	-121.546579 °
DWR ID	DWR_NA0006_01_s_2015_17				
Comment Code					
PO : Pole					
Inspector Comment

View of the poleline on the waterside of the levee facing upstream.

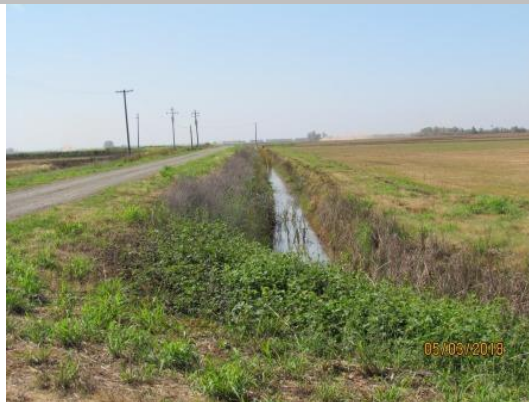
Photo 1 of 1 : SP_2019_NA0006_252_15_20190305_00003.jpg

LM Start	0.68	Rating **	M	Issue No.	15
LM End	1.45	Issue Type +	En	Location *	LS
Category	Earthen Levee			GPS Latitude/Longitude	
				Start	End
Item	Encroachments			39.297426 °	39.295260 °
				-121.558319 °	-121.546719 °
DWR ID	DWR_NA0006_01_s_2018_15				
Comment Code					
DT : Ditch					
Inspector Comment					
There is a ditch on the landside of the levee.

View looking upstream of landside ditch at levee toe.

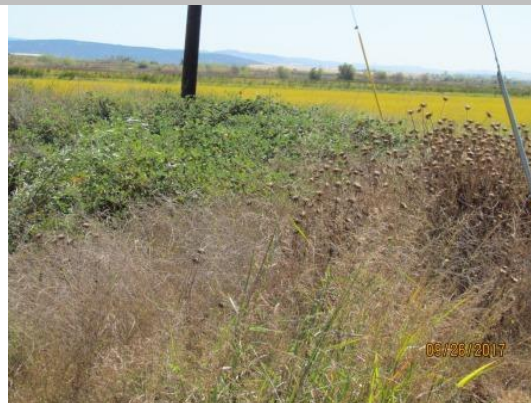
Photo 1 of 1 : SP_2019_NA0006_252_1_20190305_00001.jpg

LM Start	0.85	Rating **	U	Issue No.	1
LM End	0.96	Issue Type +	Ma	Location *	WS
Category	Earthen Levee			GPS Latitude/Longitude	
				Start	End
Item	Vegetation			39.294995 °	39.295021 °
				-121.557823 °	-121.555813 °
DWR ID	DWR_NA0006_01_f_2016_1				
Comment Code					
V2 : Remove the wild growth other than native grasses from the levee slopes.					
Inspector Comment					
Remove blackberry bushes that are starting to take over the waterside slope. Spring 2019.

View of blackberry bushes that are starting to cover the waterside slope.
Looking upstream waterside.

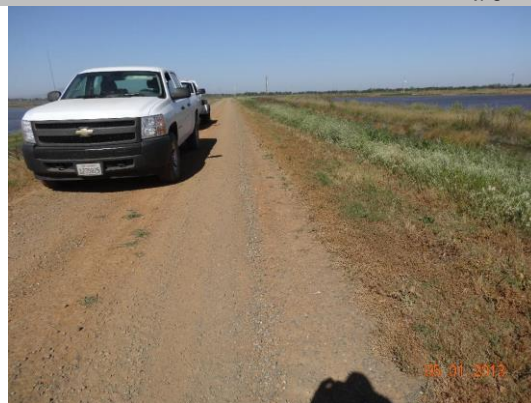
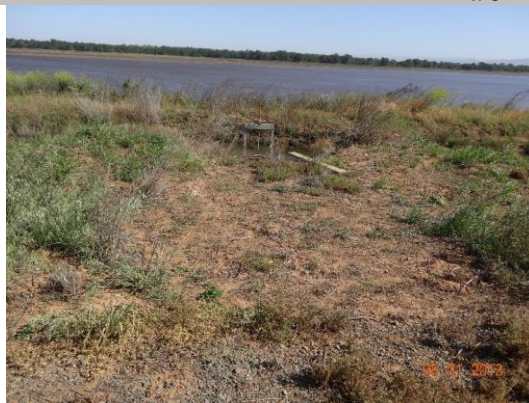
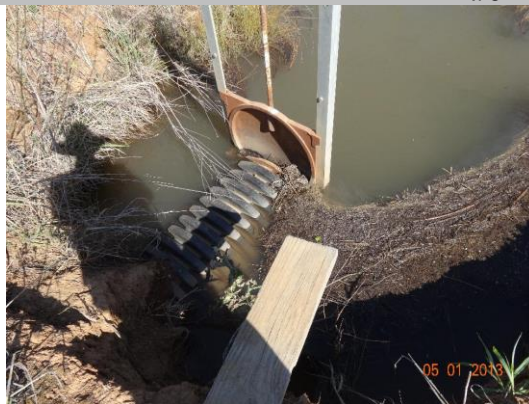
Comment Code						
Inspector Comment						
FS_ID:52802 DS_ID:19172 EP_NO: 9610 Repair Type: Non-Urgent Crossing Status: Found UCIP Comments: 05/01/2013 Scouring occuring directly across pipe on access road. Need to determine permit authorizing updates to crossing. Crossing appears to be no more than 10 years old. (DWR UCIP - O. Magana) FIELD_STRUCT_DESC: 1 of 2: 24-inch corrugated metal irrigation pipe through the levee, 6 feet below the crown. Slide gates are installed on waterside (WS) end of pipe. (two 24-inch pipe authorized Permit No. 9610, 1974-Honcut Creek Ranch). [Additional Reference(s): DWR Levee Logs, 2005. USACE Sacramento O&M Manual Unit No. 151, November 1953, (Station 53+70)] FS Date: 5/1/2013

Overview of levee crown looking upstream at crossing.

View of waterward side.

Positive closure device on waterward side.

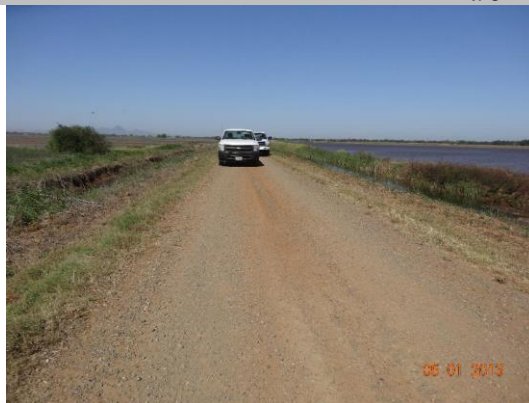
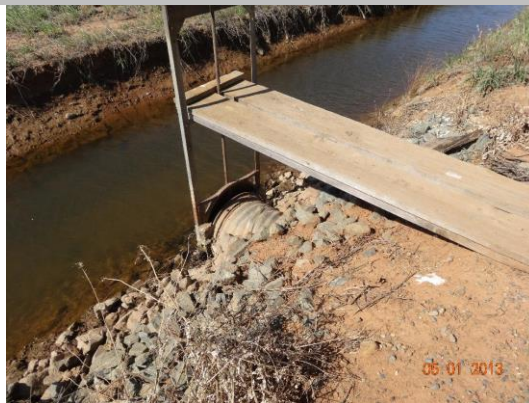
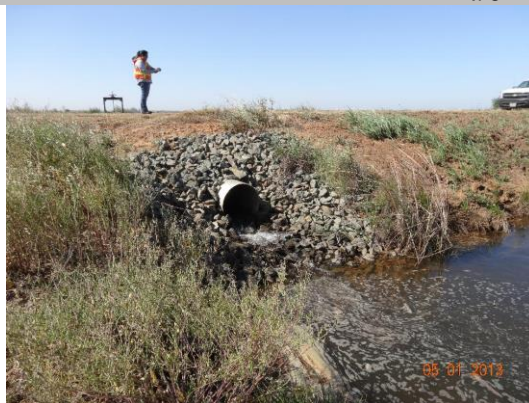
LM Start	1.17	Rating **	M	Issue No.	29	
LM End	1.17	Issue Type +	En	Location *		
Category	Supplemental			GPS Latitude/Longitude		
				Start	End	
Item	DWR UCIP Field Study			39.295099 °	39.295099 °	
				-121.551839 °	-121.551839 °	
DWR ID	19174					
Comment Code						
Inspector Comment						
FS_ID:52803						
DS_ID:19174						
EP_NO: N/A						
Repair Type: Non-Urgent						
Crossing Status: Found						
UCIP Comments: 05/01/2013 Recent repair will need to contact owner to follow-up. (DWR UCIP - O. Magana)						
FIELD_STRUCT_DESC: 24-inch corrugated metal drainage pipe through the levee, 10 feet below the crown. Flap gate located on the waterside (WS).						
FS Date: 5/1/2013

Overview of levee crown looking upstream from crossing.

View of landward side: positive closure device, walkway, and rip rap on slope.

View of waterward side crossing looks fairly new.

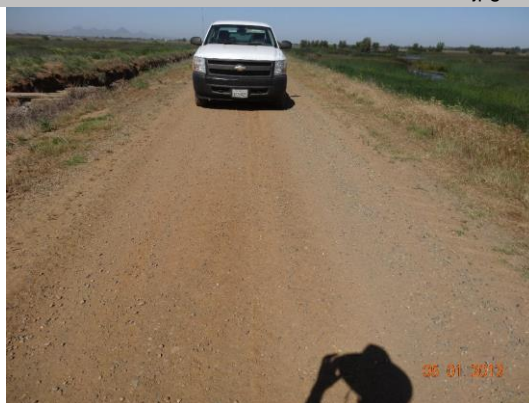
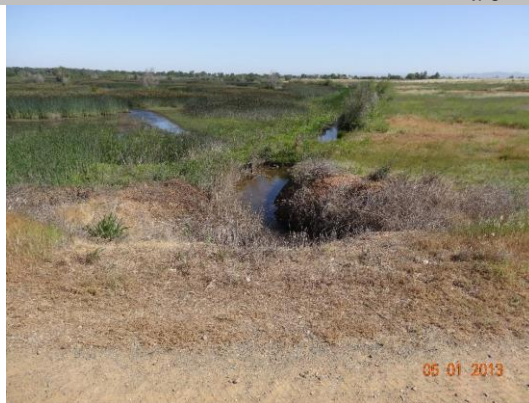
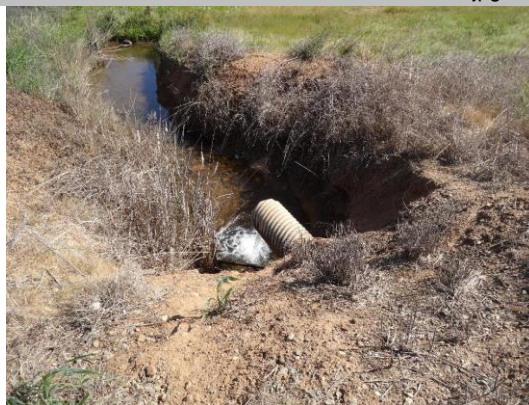
LM Start	1.44	Rating **	M	Issue No.	30
LM End	1.44	Issue Type +	En	Location *	
Category	Supplemental			GPS Latitude/Longitude	
				Start	End
Item	DWR UCIP Field Study			39.295238 °	39.295238 °
				-121.546755 °	-121.546755 °
DWR ID	19169				
Comment Code					
Inspector Comment					
FS_ID:52804					
DS_ID:19169					
EP_NO: N/A					
Repair Type: Non-Urgent					
Crossing Status: Found					
UCIP Comments: 05/01/2013 Need to determine permit authorizing work. (DWR UCIP - O. Magana)					
FIELD_STRUCT_DESC: 18-inch corrugated metal irrigation pipe through the levee, 8 feet below the crown. Slide gate located on the landside (LS) end. Rock revetment on the LS near slide-gate.					
[Additional Reference(s): DWR Levee Logs, 2005]					
FS Date: 5/1/2013

View of levee crown looking upstream at crossing.

View of waterward side.

Crossing visible on waterward side.
